Composite Bending Box section Modal Vibration fault Detection

**Rudy Werlink
NASA Langley Research Center
21 Langley Blvd Mail stop 424
Hampton, Virginia**

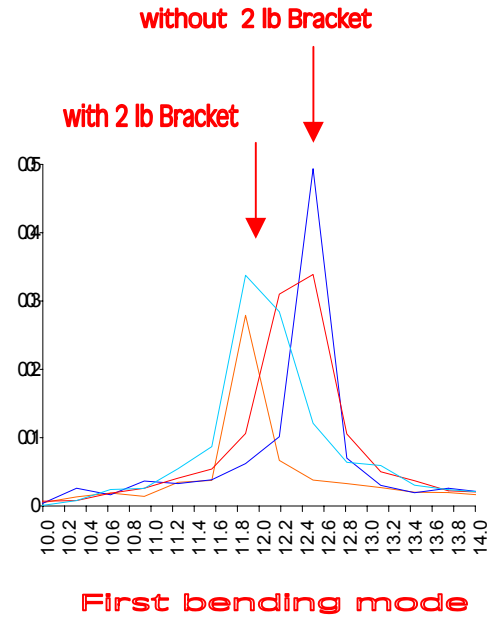
The detail above shows that you can not tell from the First bending mode that a de-bonding failure has occurred since The spars and ribs have not failed. The sensitivity of this mode to the addition of the 2-lb bracket is easily seen by the lowering of the bending frequency by about $\frac{3}{4}$ hertz.

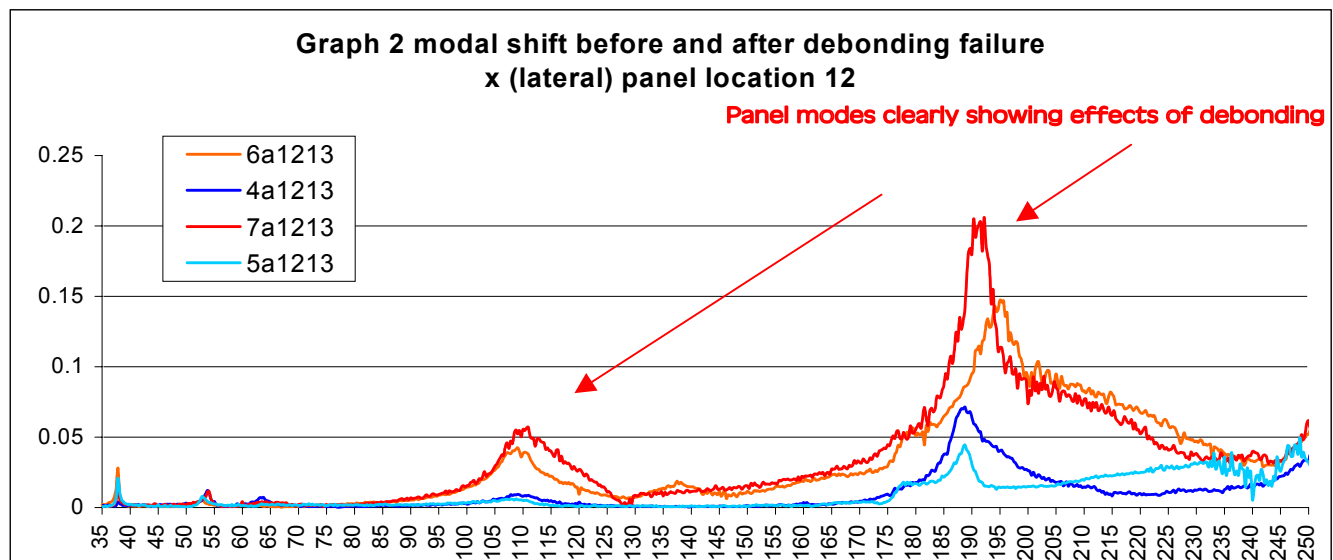
Shown in Graph 2. The very different magnitudes around 110 and 190 hz indicate a decrease in stiffness in this plane due to the carbon skin de-bonding.

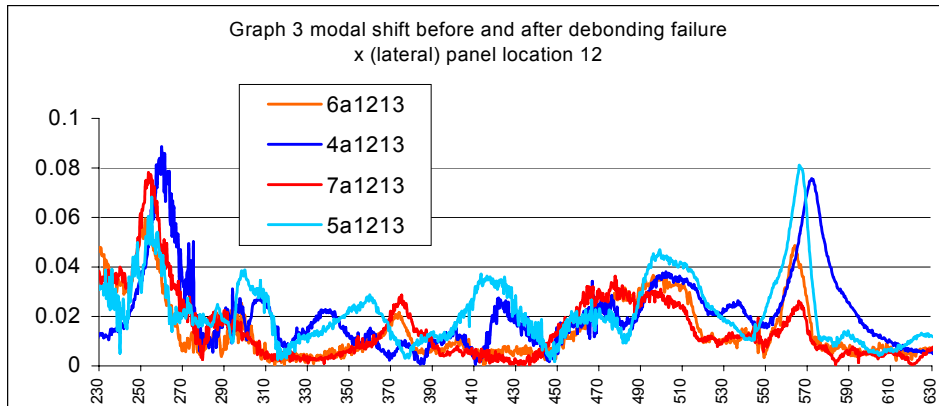
At even higher frequencies the effects of de-bonding on magnitude is much less clear as shown in Graph 3 below.

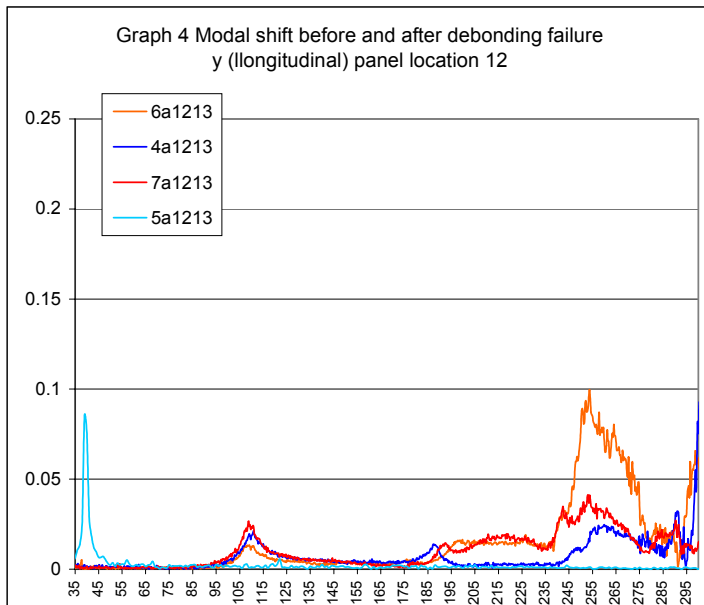
Graph 4 shows that In the y longitudinal direction the de-bonding failure and stiffness change are less apparent but still detectable.

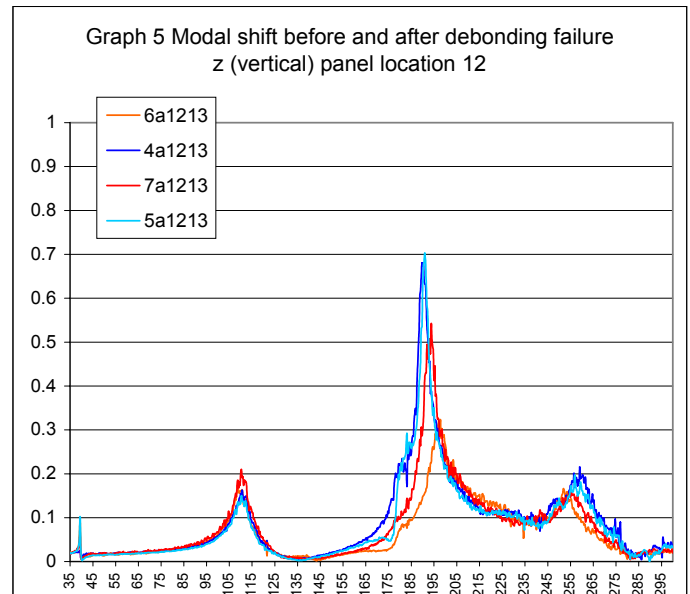
Graph 5 shows comparisons on the pre to post de-bonding failures in the vertical (z) direction show little difference. From this subset of the reviewed data it is apparent that to detect this type of failure where the main support system is still functional (load carrying) monitoring must be done in the correct direction and frequency range, else failures could go undetected.

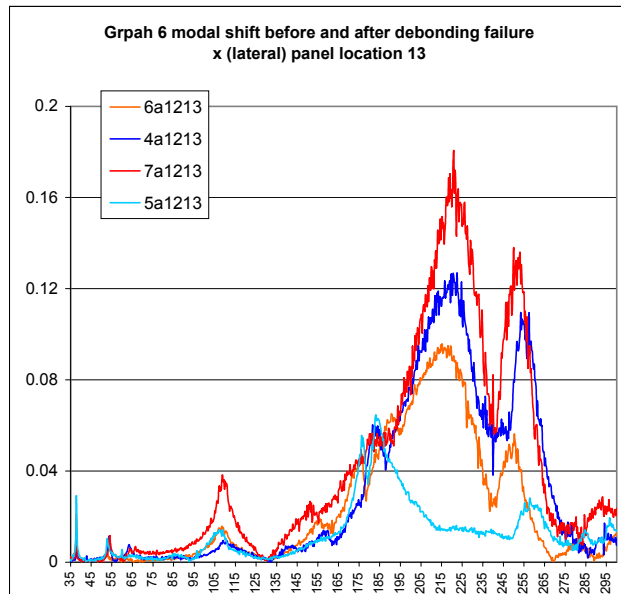
Response location is not critical if consideration is given to the underlying support structure. The panel centers which are as far away from the ribs and spars as possible provide the best indicators for the skin de-bonds. The Panels are where the failures are manifested with reduced lateral stiffness. Any of the Panel's locations 12 –17 provide similar indications of the failures (Graphs 6-9).

Graph 6 shows panel location 13 near free end

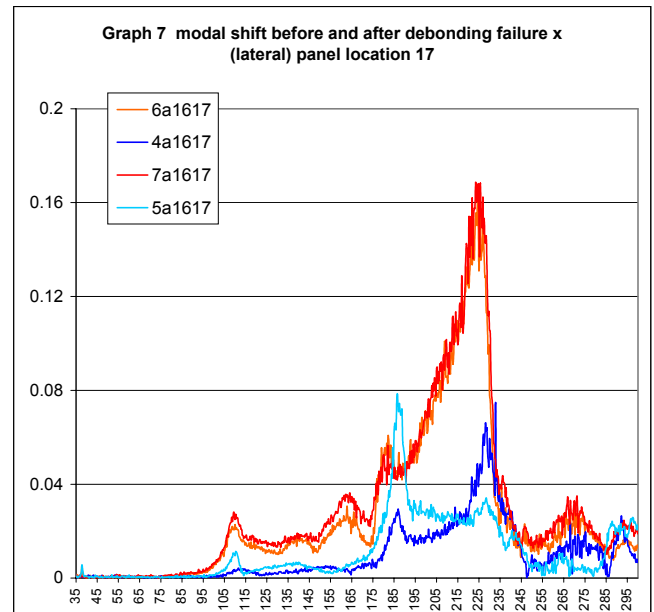
Graph 7 is panel location 17 near the mounted end

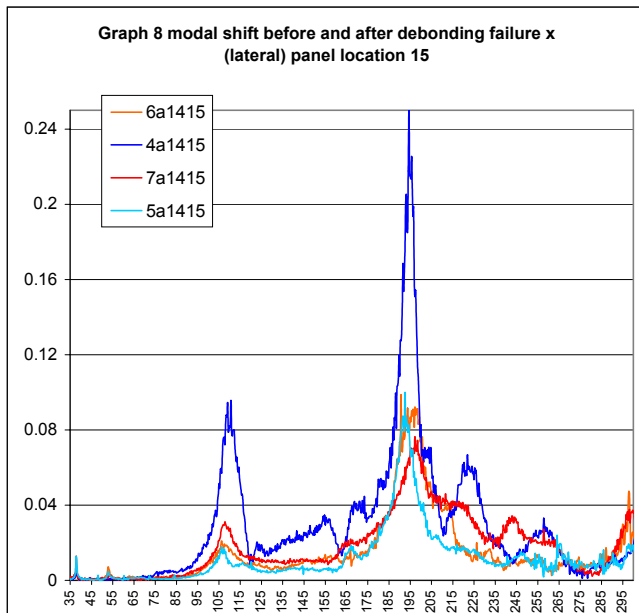
Graph 8 shows panel location 15 near the mid-section

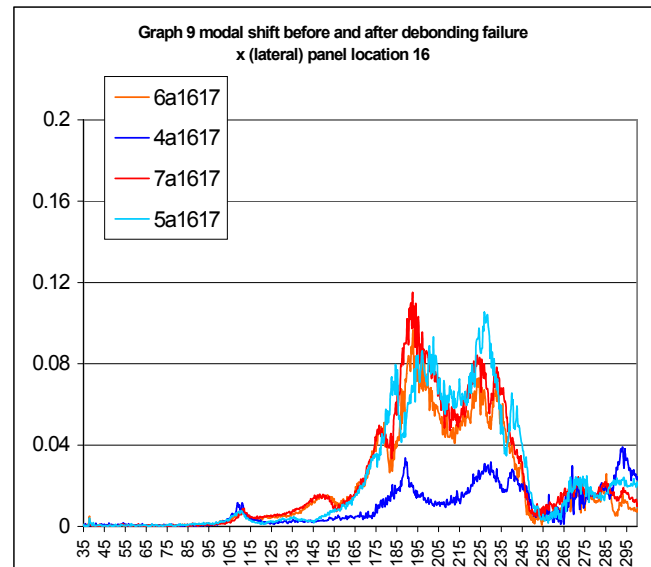
Graph 9 is panel location 16 near the mounted end

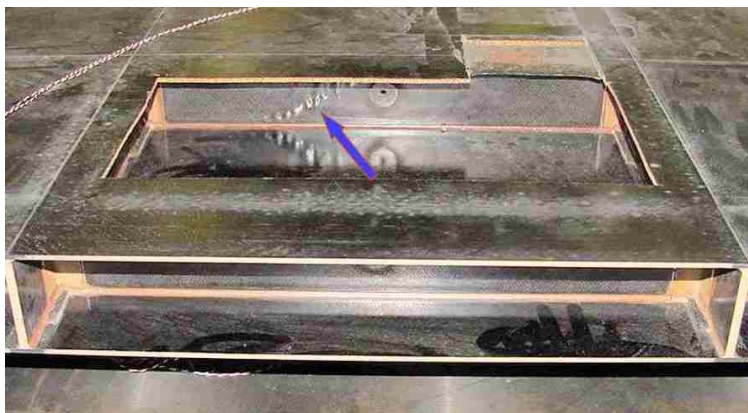
Photo 8 Carbon skin de-bond on the Main Spar side

Shown above in Photos 8 and 9 is the skin de-bonding in the main Spar side also near location 15 on the panels caused from the load to failure test.

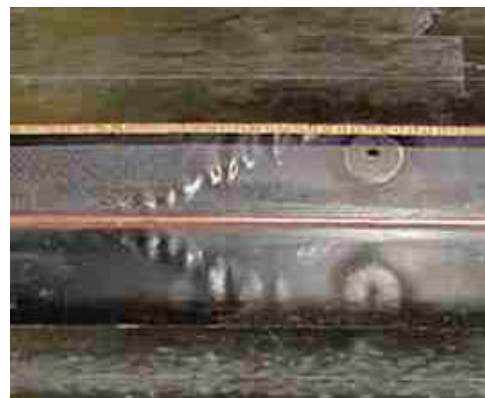
Photo 9 Close-up carbon skin de-bond

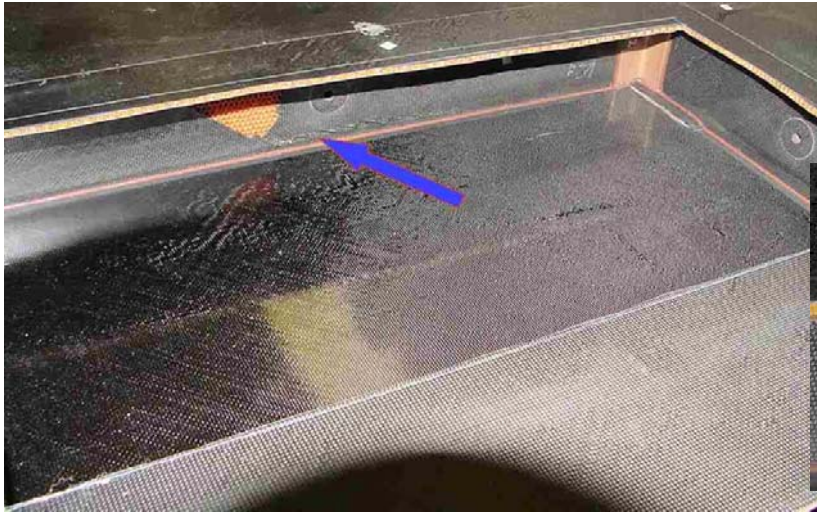
Photo 10 cutaway section near top surface skin de-bond

Photos 10 and 11 Show the skin de-bond in the top of the main spar also near panel location 15 after loading to failure

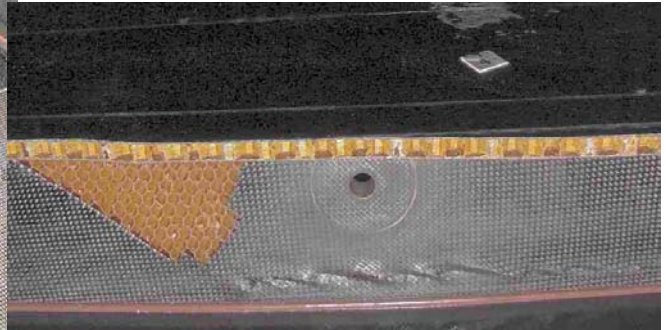
Photo 11 Close-up near top surface skin de-bond

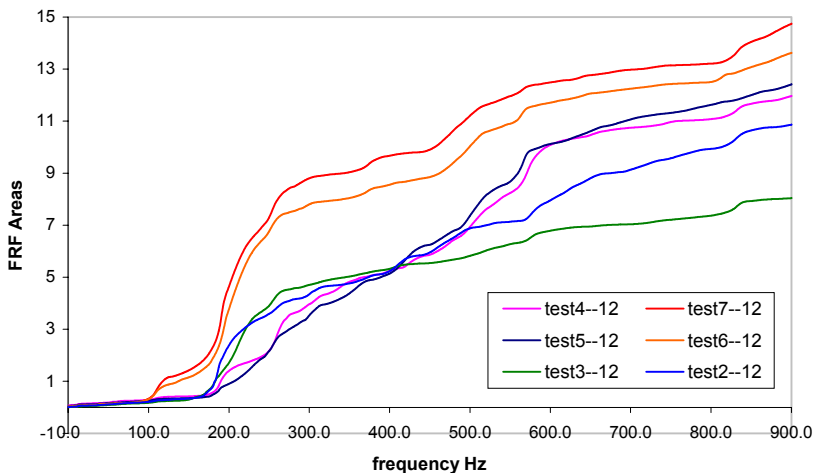
Graph 9 Area under FRF curve Location 12

Graphs 9 and 10 below show the jump in area for the Post failure modal test 6 and 7 when compared to the pre – Failure test 2-5. The frequency where the areas diverge is around 110 hz corresponding to the lowest panel modes. Frequencies below 100 hz which include the bending and torsional modes of the support structure provide no indication as expected.
